**AC&E CORP .**

In accordance with your request an inspection of the above property was made on 10/17/12. The following report is based on those findings.

**DESCRIPTION OF HOUSE: Ranch**

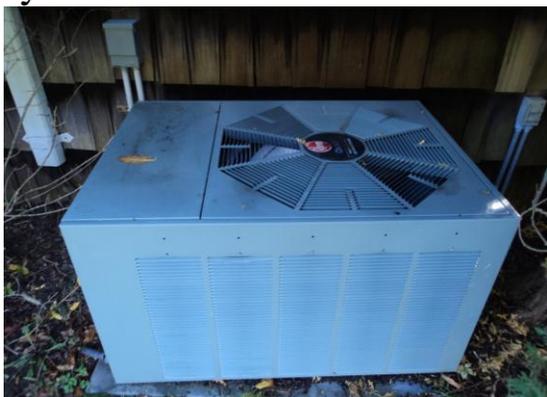
At the time of the inspection, the outside temperature had fallen below 60 degrees so the central air conditioning system was not operated to avoid the potential for damage to the condensing unit. If possible, I recommend that the air conditioning be operated prior to your final walkthrough or that the current homeowner gives you satisfactory assurance that the air conditioning system is in good working order. The system was installed in 2003.

Recommend removing the leaves from the air conditioning condensing unit and covering it while it is out of service for the season to prevent further debris from getting in.

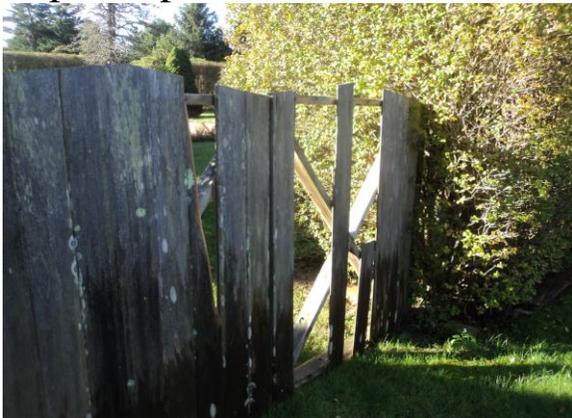
Repair/replace sections of broken fence in the yard where required.

Wood fencing is installed around the perimeter of the property. I recommend power washing and staining/painting to minimize potential for weather damage and to extend its useful service life.

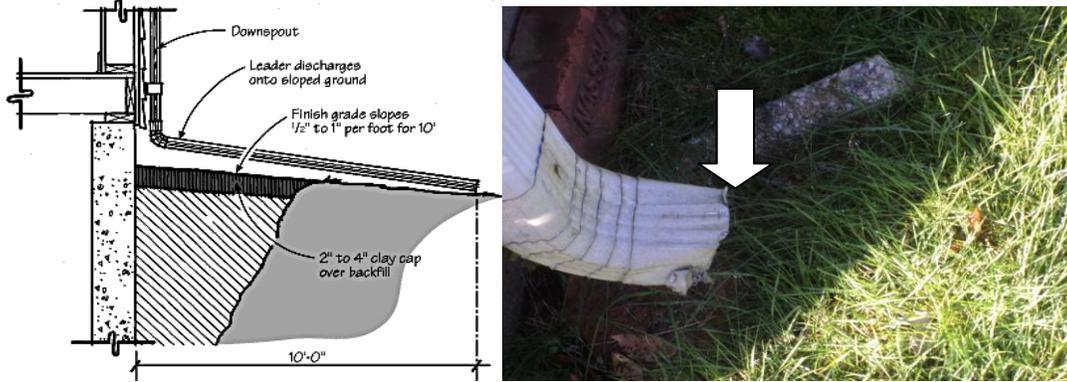
Recommend that gutter extensions be added to downspouts in a couple of locations to channel water away from the foundation during rain events. Additionally, I recommend that roof gutters be cleaned out as part of a regular maintenance program. The present configuration of the gutters allows water to seep into the ground around the foundation creating added stress on the structure and possibly creating a condition for water migration into the house.

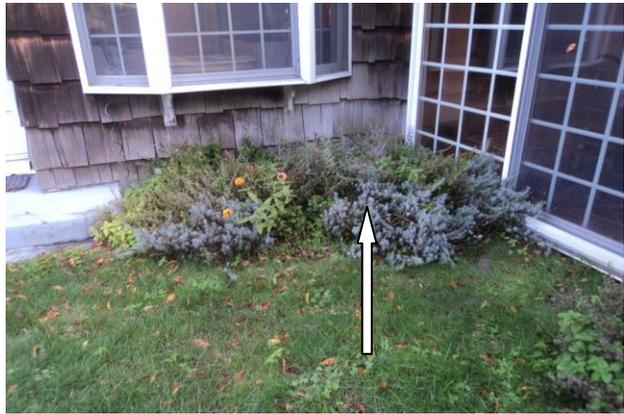
The home had areas of neutral or negative drainage at grade which will route runoff from precipitation to the foundation. Excessive moisture content in soil supporting the foundation can cause foundation and other structural damage from undermining, heaving or settling, depending on soil composition, moisture content and other conditions.

The ground should slope away from the home 1/4-inch per foot for a distance of at least six feet from the foundation.

The Inspector recommends re-grading these areas to improve drainage near the foundation.

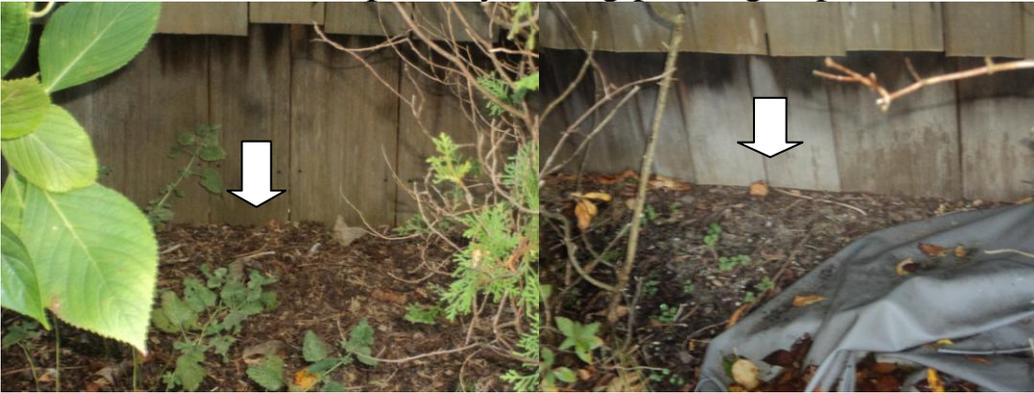
The top of the foundation wall had inadequate clearance from grade. The top of the foundation wall should be a minimum of six inches above soil. Inadequate clearance may result in moisture intrusion of the structure. Excessively high moisture levels can result in damage to the home structure or materials from decay or deterioration and may result in conditions which encourage the growth of microbes such as mold fungi. Excessive growth of mold fungi can produce high concentrations of mold spores in indoor air which can cause serious health problems in some people. Door thresholds should be kept sealed and the base of the exterior walls monitored for moisture intrusion, especially during prolonged periods of rain.

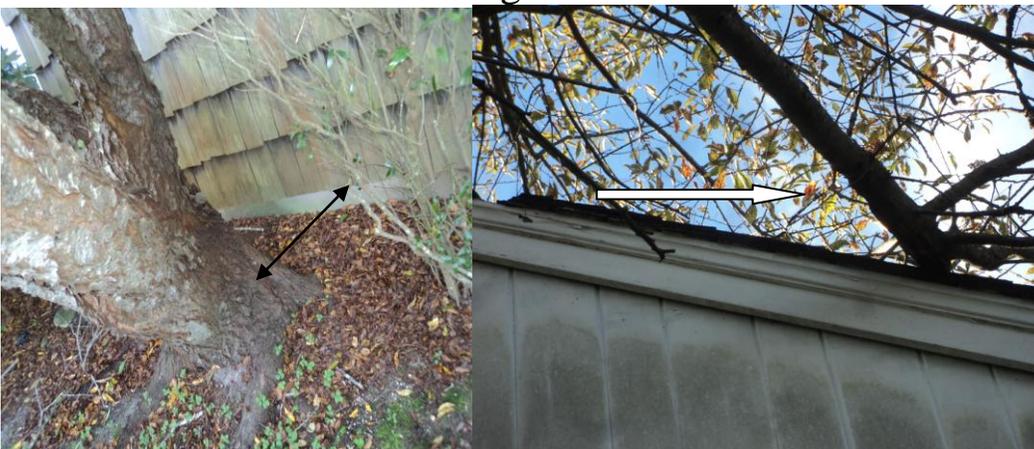
Recommend removing the tree that is too close to the foundation in the front of the house. The tree is also rubbing the roof line.

Recommend trimming of trees and bushes away from the house to minimize potential for damage from wind and wood boring insects.

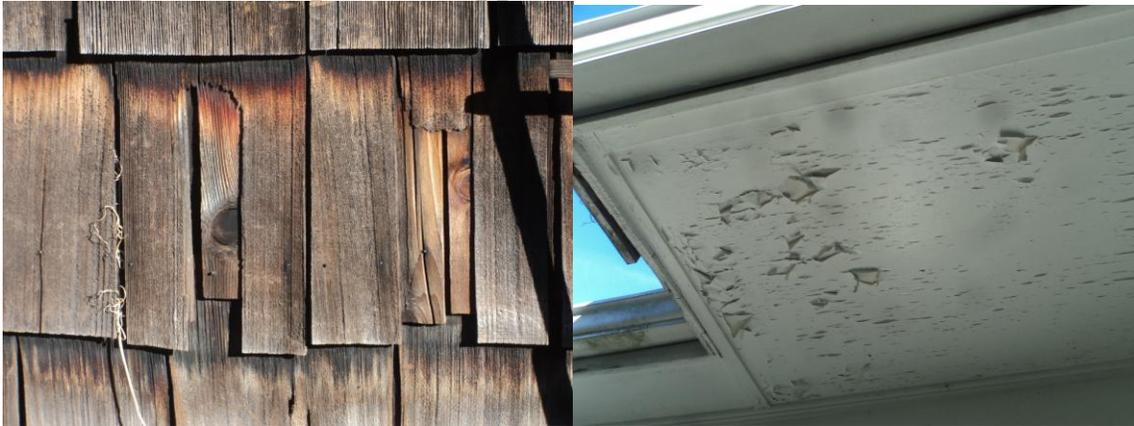
RECOMMENDATIONS: Deteriorated wood shingles were observed in a number of areas. I recommend replacement of all affected shingles. Additionally, peeling paint was observed in a number of exterior/interior locations around the house. As the house predates 1978, the potential exists that the paint may contain lead. To minimize the potential for any adverse health effects, I recommend that the paint be properly scraped off and disposed of. Subsequent to that, I recommend that a fresh coat of primer and paint be applied.

Note the house is in need of re-shingle due to the number of worn shingles.

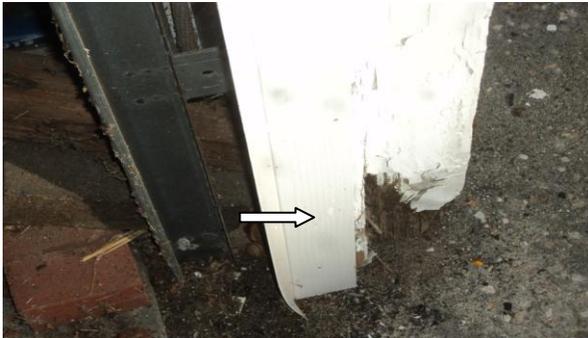
Some wood rot was observed in exterior wood pieces (i.e. garage door frame, etc.). I recommend that all affected wood pieces be replaced.

Recommend setting up a budget for replacing the original wood garage doors.

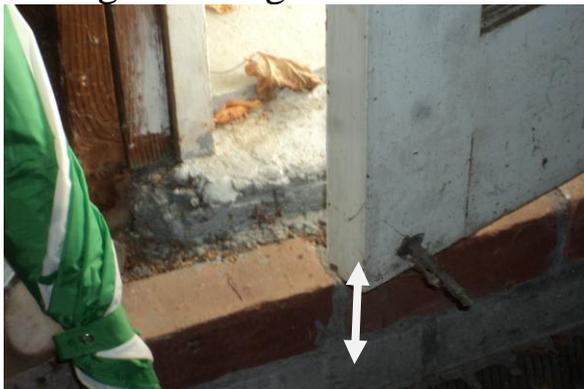
Note the side door leading into the garage improperly opens over a step. Recommend having a landing installed in this location.

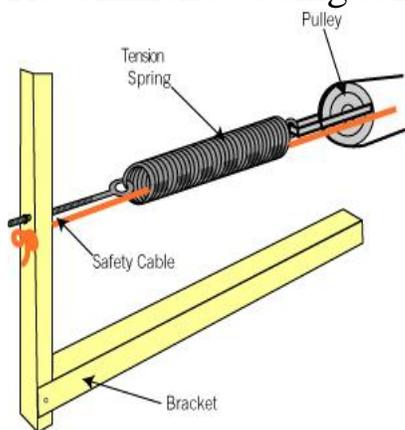
Recommend replacing the automatic garage door opener with one with child protection.

Recommend adding safety cables to the garage door springs.

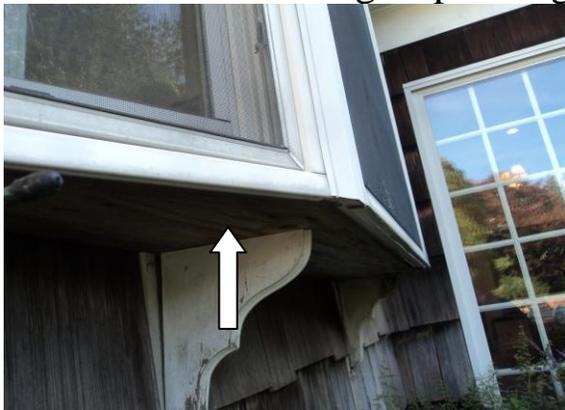
Recommend covering or painting the wood under the bay windows.

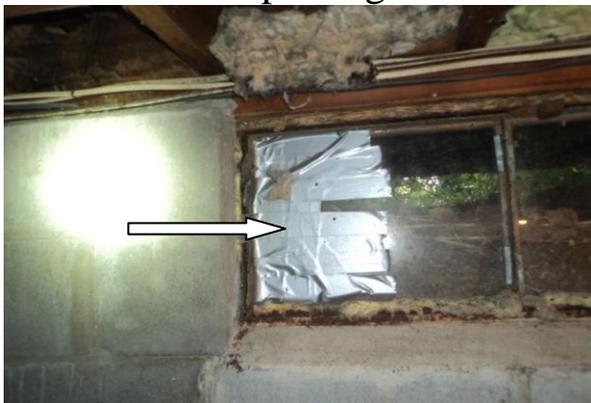
Recommend replacing the broken rear basement window.

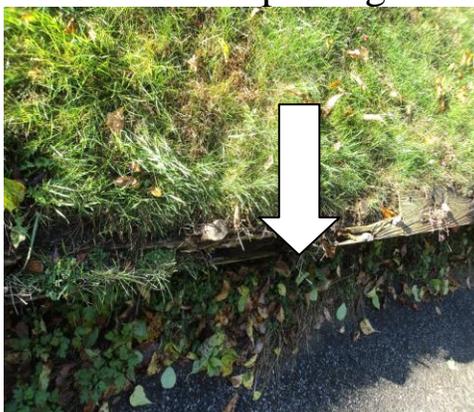
Recommend replacing the rotted wood retainer wall along the driveway.

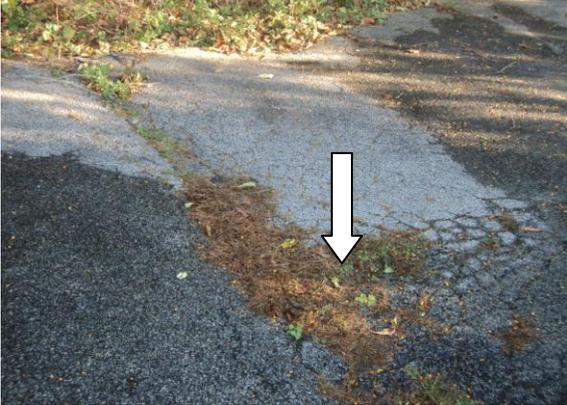
Recommend setting up a budget for a replacement driveway as the asphalt driveway was in poor condition.

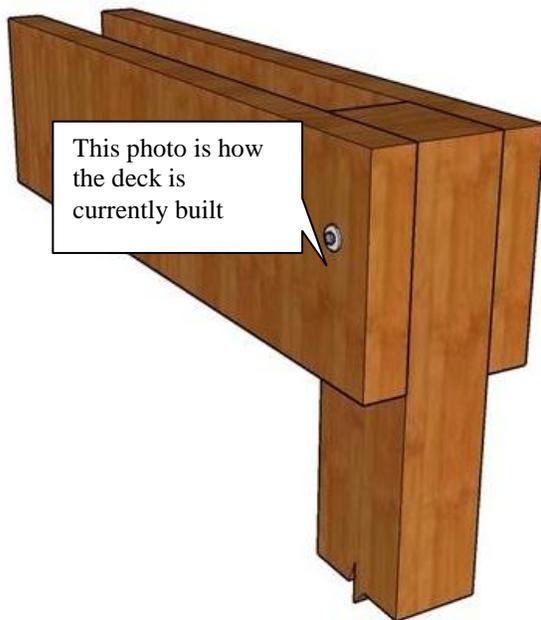
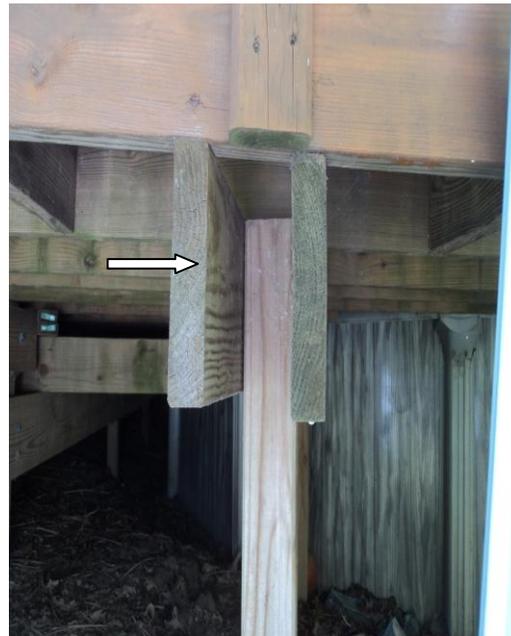
The current deck was improperly constructed as the headers are bolted to the supports posts. This type of set up can cause a deck to collapse if the bolts rust out and shear off. Recommend having this deck re-built at this time.

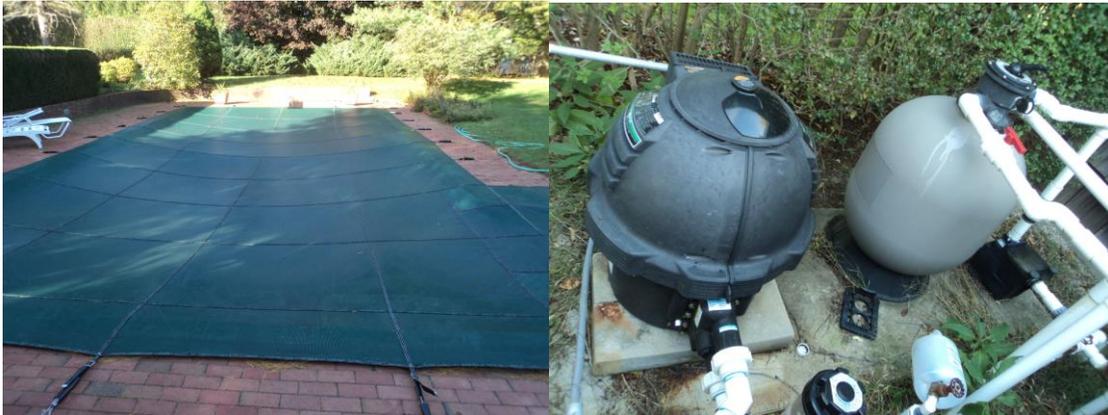
An in-ground pool is present in the rear yard. At the time of this inspection, the pool was covered for winter making it inaccessible for a visual evaluation. Recommend the current homeowner verify that the pool (i.e., liner, filter, pumps, heaters etc.) are in proper working order and free of leaks.

Recommend you have a qualified pool contractor inspect this liner and estimate its remaining service life. Budget to replace the liner as necessary. The realtor stated that the pool liner was in poor condition and in need of replacement.

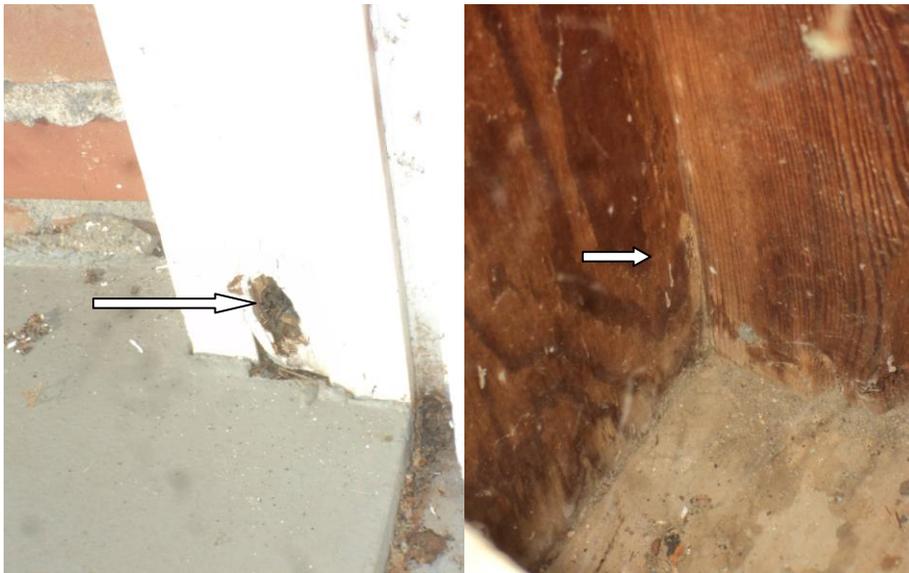
There was termite damage noted in the garage to the left side wall and to the garage door frame on the left side of the garage. Recommend replacing any damaged members that are visible or hidden from view within the walls and obtaining treatment at this time.

Recommend replacing the rotted wood on the center garage door frame as the frame moves.

Recommend adding weather seals to the garage doors.

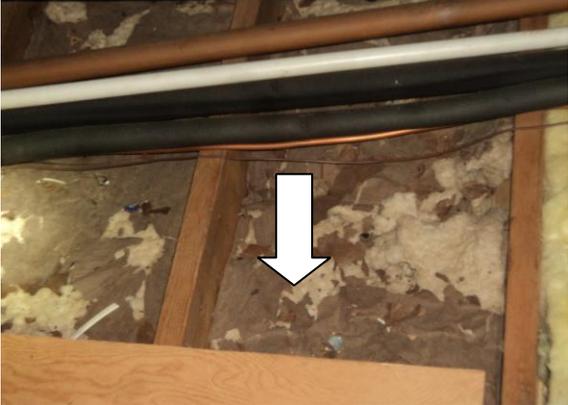
Recommend having additional insulation installed in the attic as limited insulation was noted.

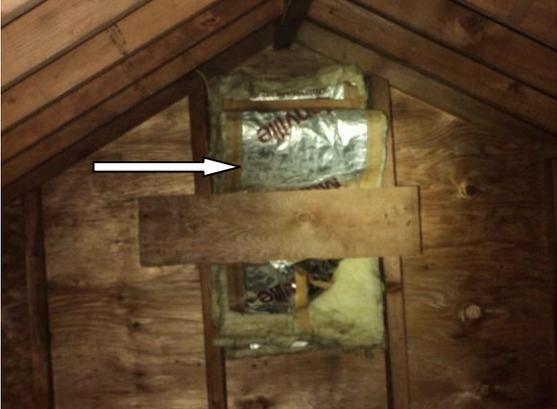
Recommend opening the gable vent that was blocked on the right side of the house.

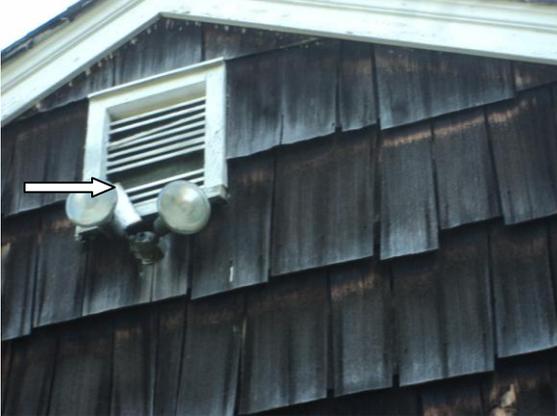
Recommend replacing the broken gable vent on the right side of the house.

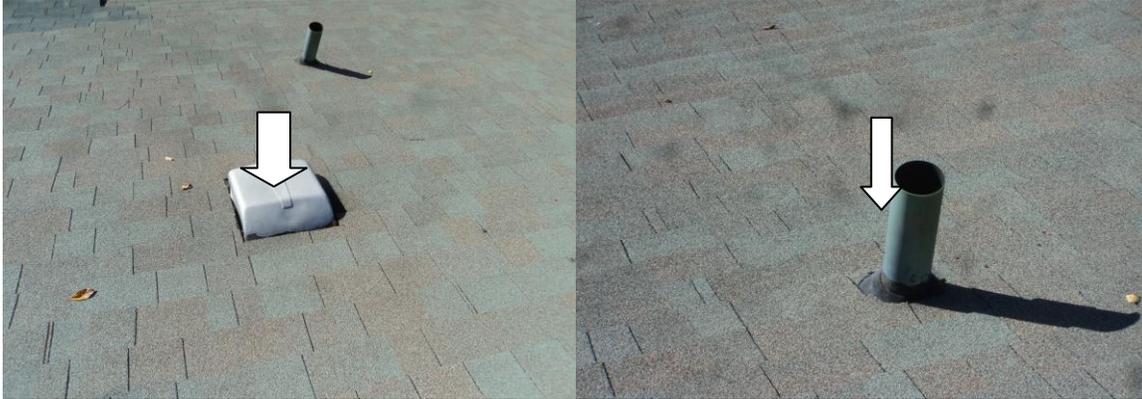
Recommend having the roof/septic vents properly flashed.

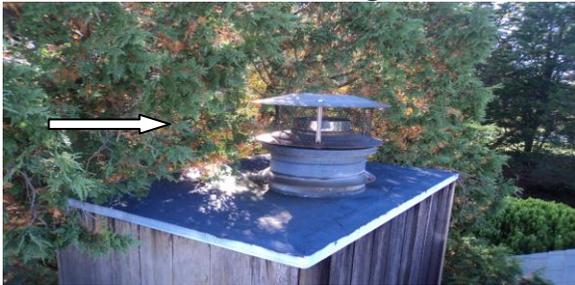
Recommend trimming the tree back from the chimney.

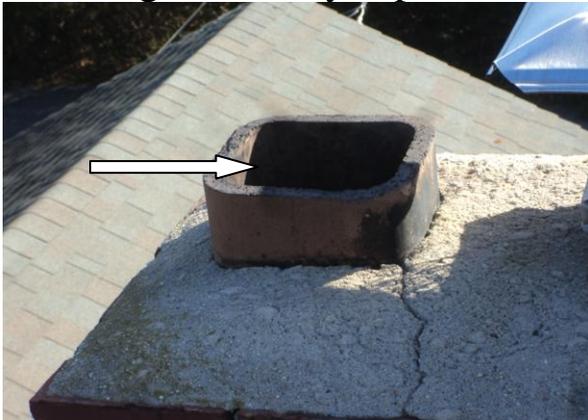
Chimney: I recommend having the chimney flues cleaned and camera inspected by a chimney service company prior to going to closing on the house. Recommend installing a chimney cap for the chimney.

Recommend having both the chimneys properly flashed at this time at the roof line.

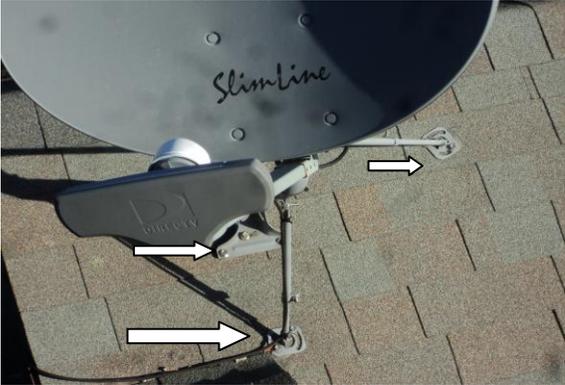
Recommend tar seal on exposed bolts.

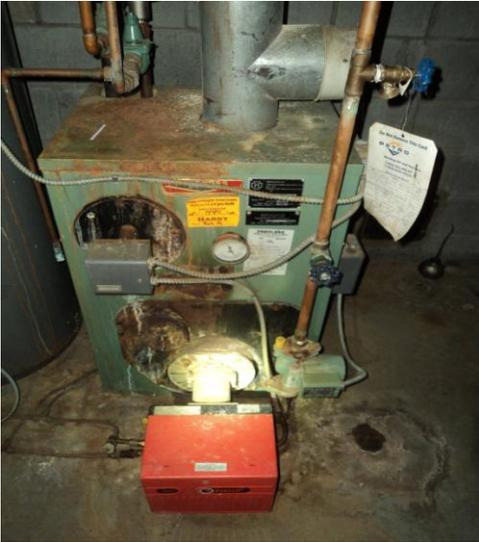
TYPE: Peerless oil fired hot water heat system with one zone and 116,000 btus.

GENERAL VISUAL CONDITON: Poor

RECOMMENDATIONS: Recommend having the unit serviced and maintaining a service contract. The heating system was working properly at the time of the inspection.

The heating system appears to be original to the house. Due to the age of the system it would be my recommendation to set up a budget for future replacement.

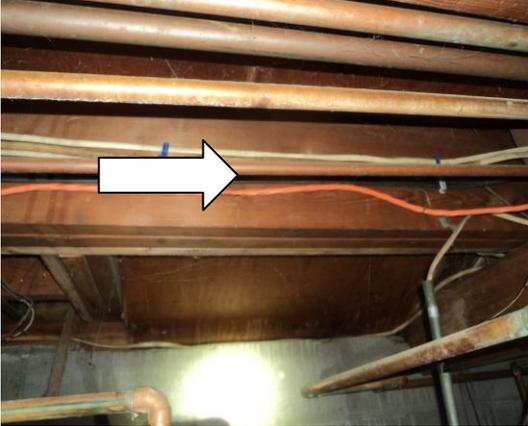
At a minimum, 5/8” thick fire-stop sheet rock has to be installed above the boiler at this time for fire stopping purposes.

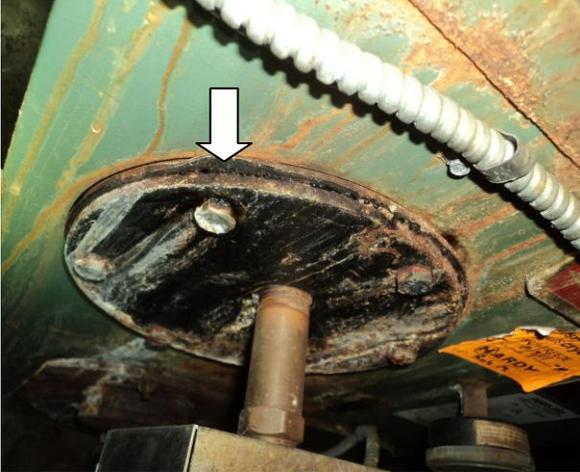
Recommend replacing the dry rotted/leaking coil gasket.

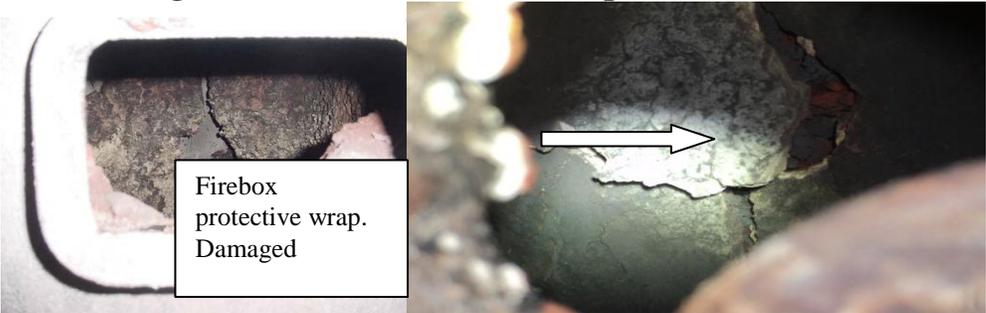
At the time of the inspection the internal protective wrap on the firebox in the boiler was damaged and in need of re-wrap at this time.

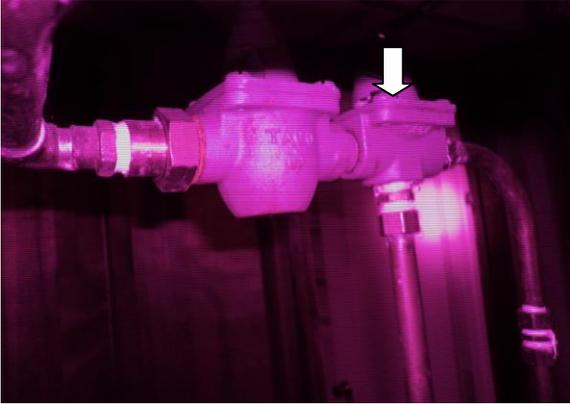
The pressure relief valve on the boiler was only a pressure relief valve and not a temperature release valve. This system needs temperature relief valve installed on the rear of the boiler at this time for safety.

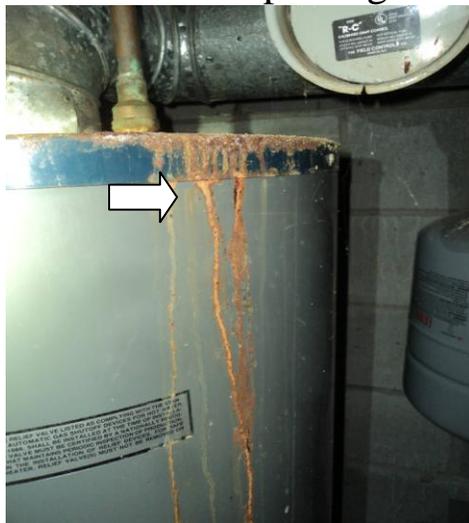
Recommend replacing the leaking hot water heater.

Hot water heaters and storage tanks can rupture with little or no warning. At the first sign of any leak, it is our highest recommendation that the tank be replaced. The service life of a heater is limited; therefore I recommend that the owner produce paperwork stating when the system was installed.

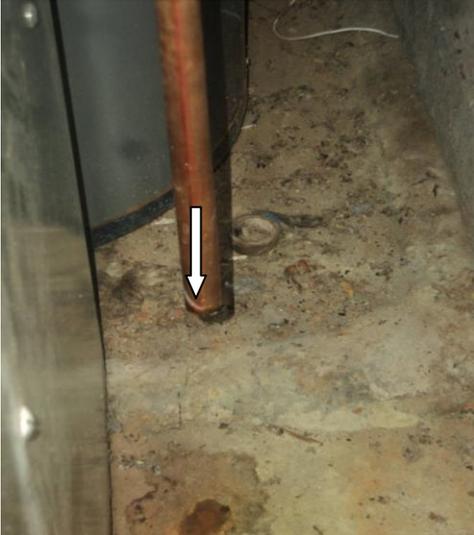
The discharge pipe of the boiler pressure relief valve was leaking. Recommend replacing the valve.

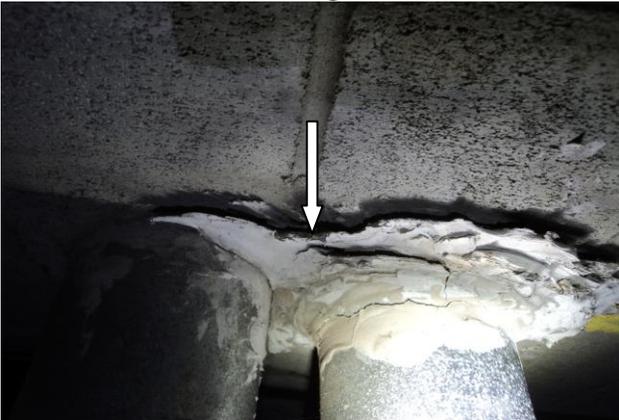
Recommend sealing around the flue pipe on the heating system at this time.

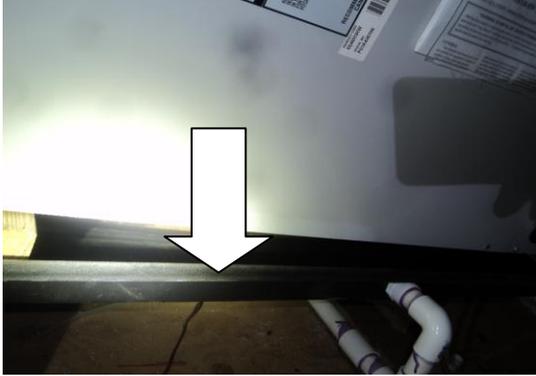
At the time of the inspection there was water noted in the emergency over flow pan in the attic. Water should never be in this pan. Recommend having an HVAC company come out at this time and repair the system as required.

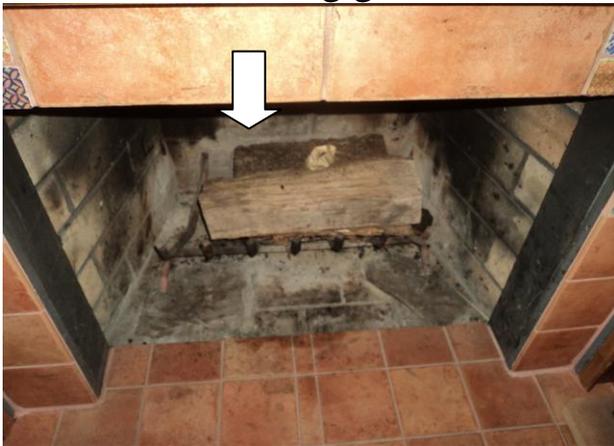
Recommend adding glass doors to the fireplace.

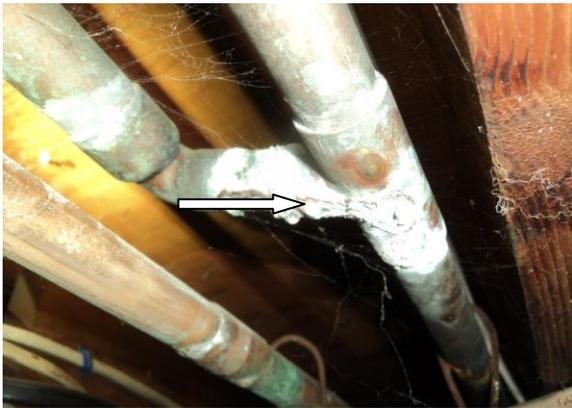
RECOMMENDATIONS: Recommend repairing the leaking pipe on the ceiling near the boiler.

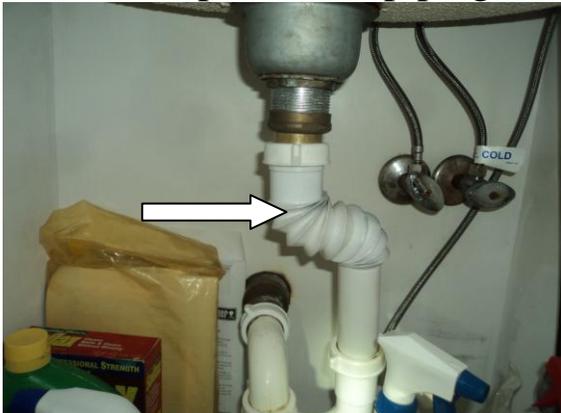
The kitchen sink uses a corrugated tailpiece drain. These are not allowed for sanitary reasons. Replace with piping that has a smooth interior surface.

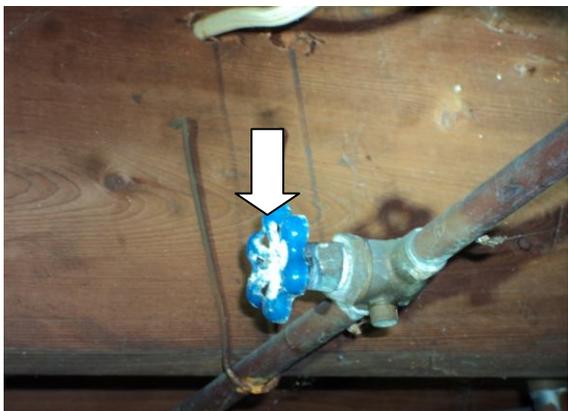
Several copper pipes and valves were observed to have surface corrosion and should not be handled or a leak could occur. Recommend replacing all old valves.

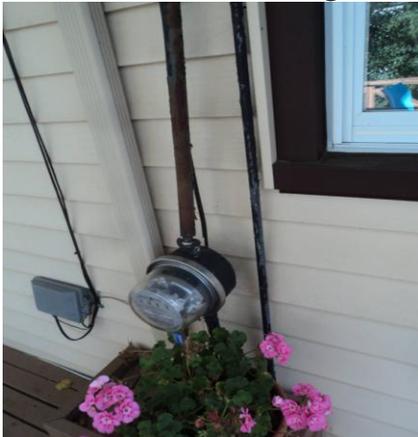
Recommend having the electric meter and wire secured to the house.

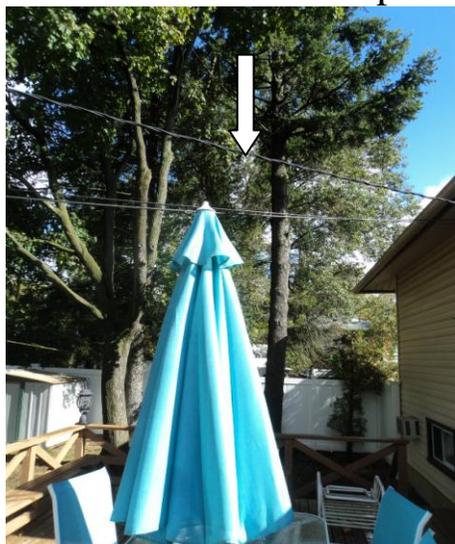
The overhead service-drop conductors have inadequate clearance from the deck. This is designed to prevent persons from coming into contact with energized electrical conductors, a shock/electrocution hazard. The Inspector recommends that before the expiration of your Inspection Objection Deadline, you consult with a qualified contractor to discuss options and costs for correction. Any work on the service conductors should be performed by a qualified electrical contractor only.

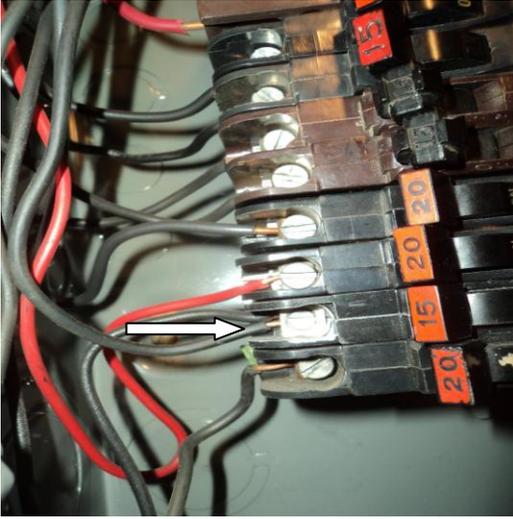
At the time of the inspection the house had a **Federal Pacific Stab-lok** electric panel to the main and sub panel. This type of panel had had a number of recalls in the past with breakers failing to trip and breakers when turned off still allowing electric to flow. It is our recommendation to have this panel replaced at this time. Some insurance companies now require that their policy holders replace FPE Stab-LOK equipment in the home before they will issue homeowners insurance for the property. Recommend replacing the panel.

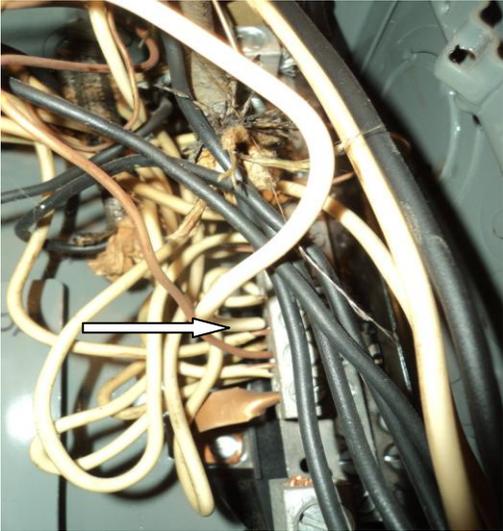
At the time of the inspection there was more than one white wire under a screw head on the side bus bar in the electric panel. Only one white wire should be under a screw head in this location. Recommend having an electrician correcting.

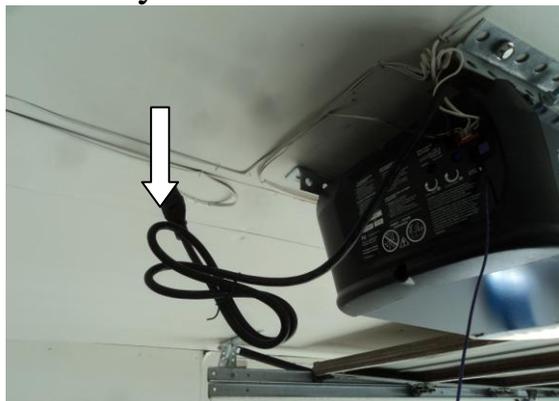
Recommend having an outlet installed above the automatic garage door opener as currently it is run off an extension cord.

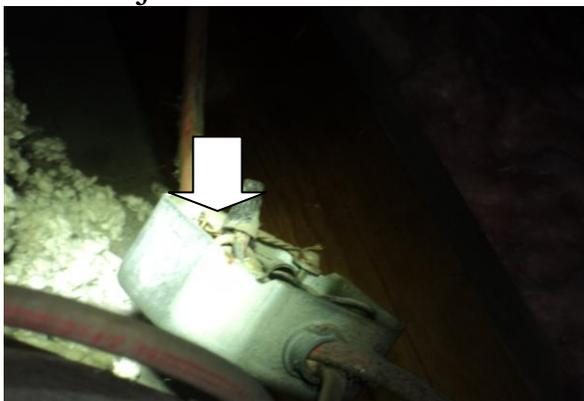
All wires should be enclosed in UL listed junction boxes and all light switches/receptacles should be properly covered. Recommend capping the open electric junction box in the attic.

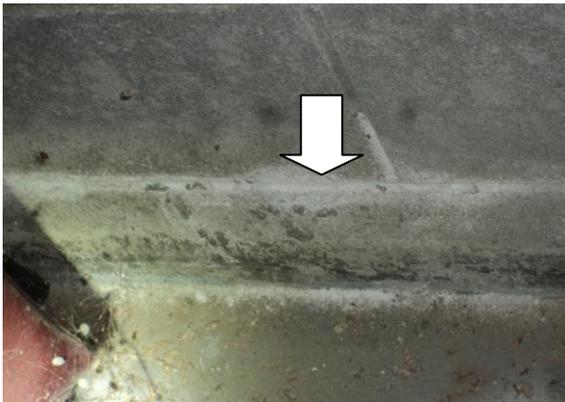
There was also efflorescence on the concrete foundation. Efflorescence is a white mineral accumulation that occurs when moisture seeps through the foundation and then evaporates, leaving behind minerals that had been dissolved in the water. Therefore, the presence of efflorescence indicates the foundation has been subject to historical and continual moisture infiltration. Consult with a water proofing company to determine the best means and methods of addressing this moisture infiltration.

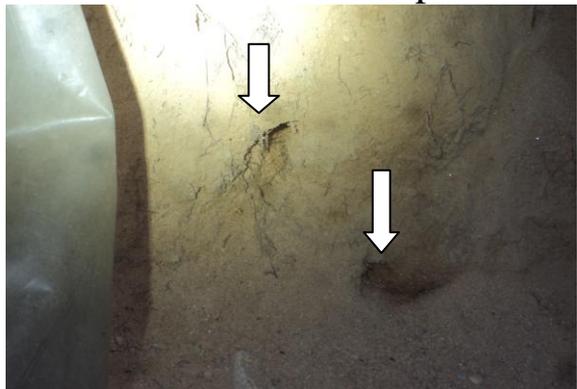
Recommend adding a concrete scratch slab to the dirt floor in the crawl space.

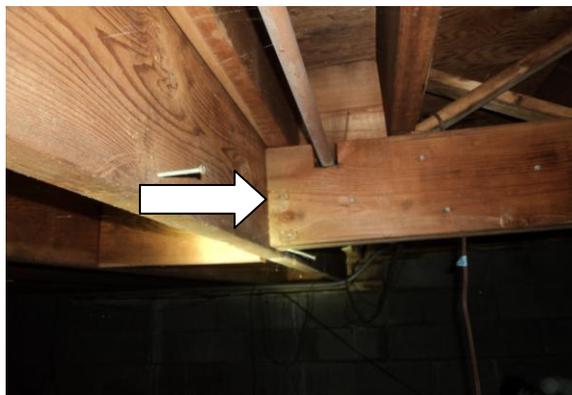
Recommend adding a hanger strap under the header in the basement that was toe nailed.

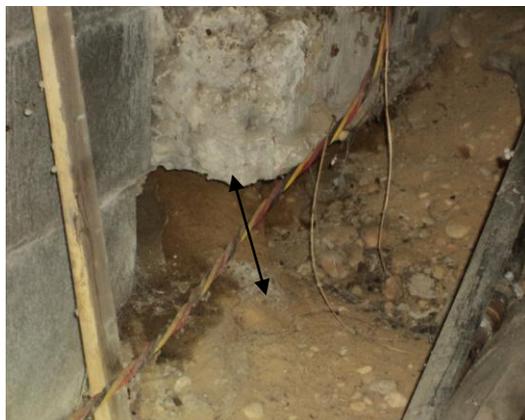
Recommend closing the areas in the foundation that were starting to undermine due to the loss of soil under the foundation in the crawl space.

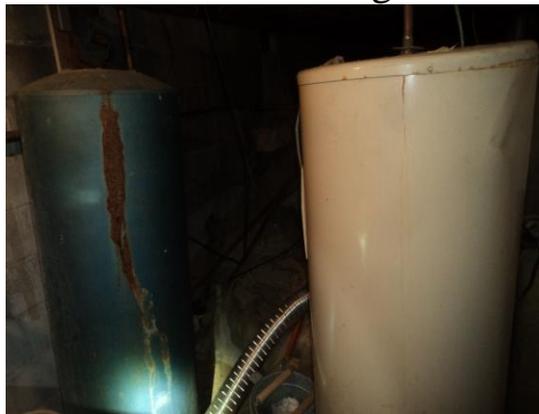
Recommend removing the old hot water heater and water tank from the basement.

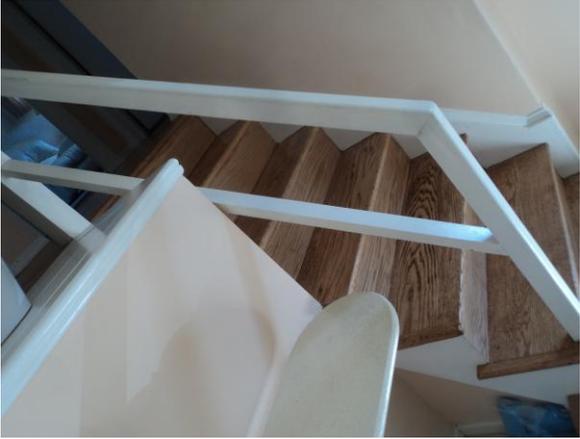
Excess rail space was noted to the handrails for the 2<sup>nd</sup> floor. Rail space should not exceed 4 inches.

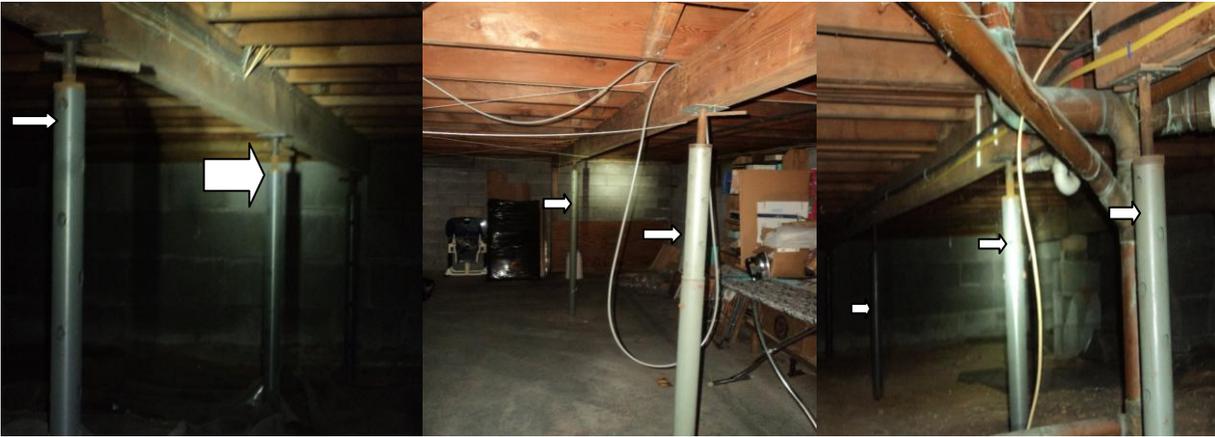
Recommend having the temporary lolly columns replaced with permanent steel lolly columns at this time.

This is a defect because no telescopic adjustable column has been evaluated by a U.S. evaluation firm and none of their manufacturers cite an engineering report to prove these columns' ability to carry a specific load. Also, according to the IRC, a steel column has to be at least 3 inches in diameter. All telescopic columns are all less than 3 inches in diameter. You must therefore assume that these adjustable columns are not designed for permanent structural use. Think of these telescopic columns the way you would think of a car jack. They only exist to temporarily "jack up" a part of a building and should be replaced with a permanent column when the jacking up is done.
