**AC&E CORP .**

In accordance with your request an inspection of the above property was made on 10/17/12. The following report is based on those findings.

**DESCRIPTION OF HOUSE: Ranch**

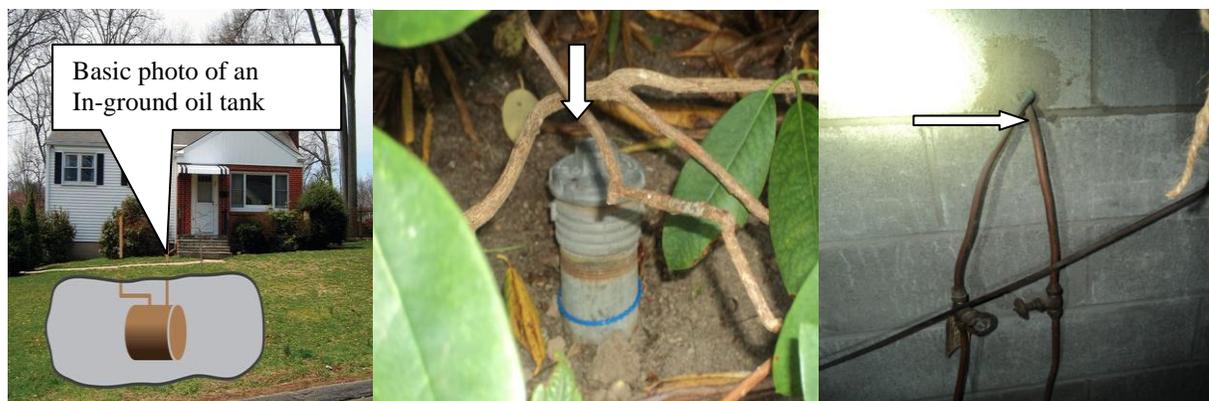
**At the time of the inspection there was an in-ground xxx gallon oil/gas tank at xx years of age. It is our highest recommendation to accomplish a leak check at this time due to possible contamination to the soil. Often times the owner would rather abandon the tank in place than test, but this would not tell you whether or not the tank is leaking. Past oil bills can possibly determine whether or not there is a large leak in the tank, but would not pick up a small leak. Soil and/or tank testing is the only way you can be sure you do not have an environmental problem. If needed, at AC&E we can accomplish an EPA approved, NON-pressure test and/or soil testing. Please see the enclosed literature on in-ground tanks.**

If soil testing is to be done all test results must be submitted to an independent lab to ensure proper clearance testing. Testing with a PID meter is not accurate.

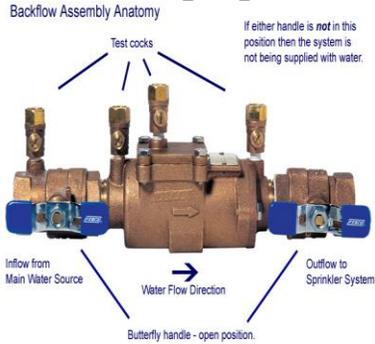
Photo of a proper check valve.

Recommend having a proper back flow check valve installed on the sprinkler system at this time.

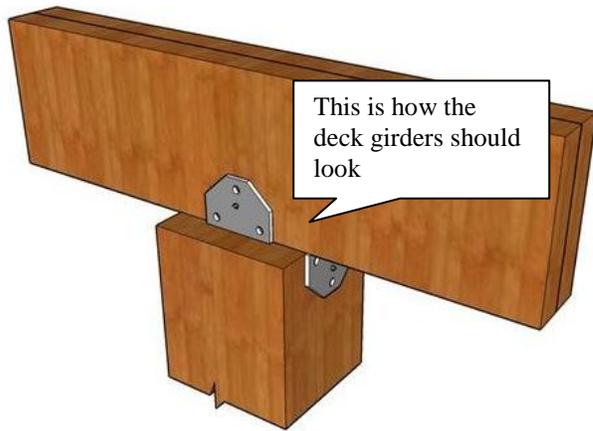
The image above depicts a girder properly resting on a post. Girders should bear directly on posts.

The current deck was improperly constructed as the headers are bolted to the supports posts. This type of set up can cause a deck to collapse if the bolts rust out and shear off. Recommend having this deck re-built at this time.

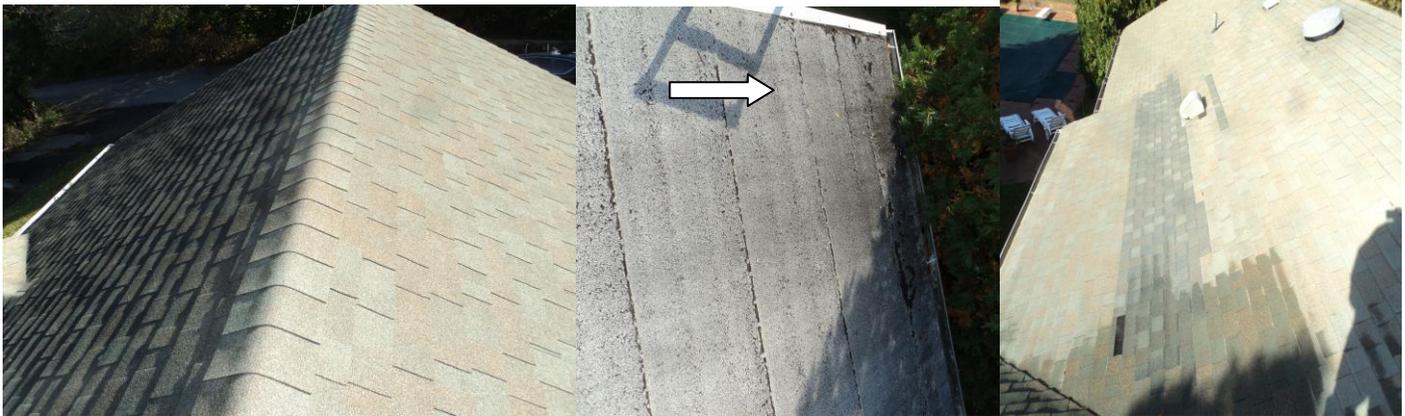
**ROOF:** Asphalt shingle with 2 layers and a rolled asphalt roof.

**GENERAL VISUAL CONDITION:** Fair on the main roof and Poor on the roof over the porch.

**APPROXIMATE AGE:** 10 years on the roof on the house and 15+ on the roof over the porch.

Recommend replacing the roll roof at this time as the roof was worn to base.

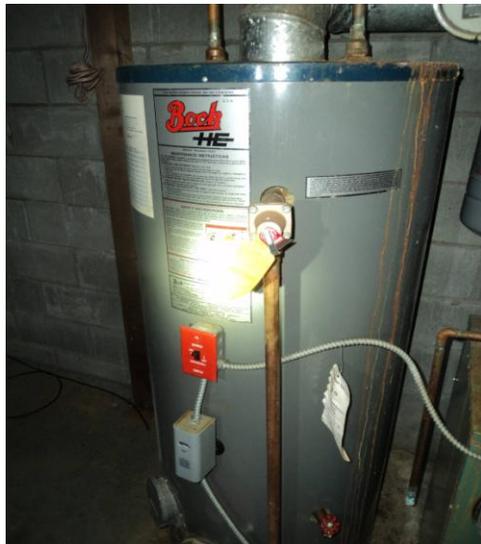
Currently, the hot water in the house is heated from a 50 gallon oil fired hot water heater.

Recommend replacing the leaking hot water heater.

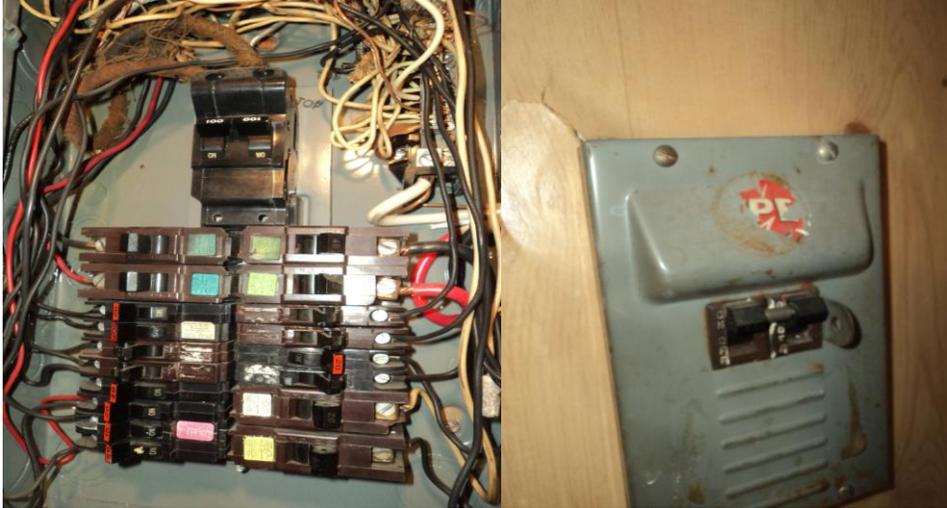
SERVICE: 100-amp service with 240 volts and 17 total breakers with copper incoming service and copper branch circuits throughout the house

GENERAL VISUAL CONDITION: Poor

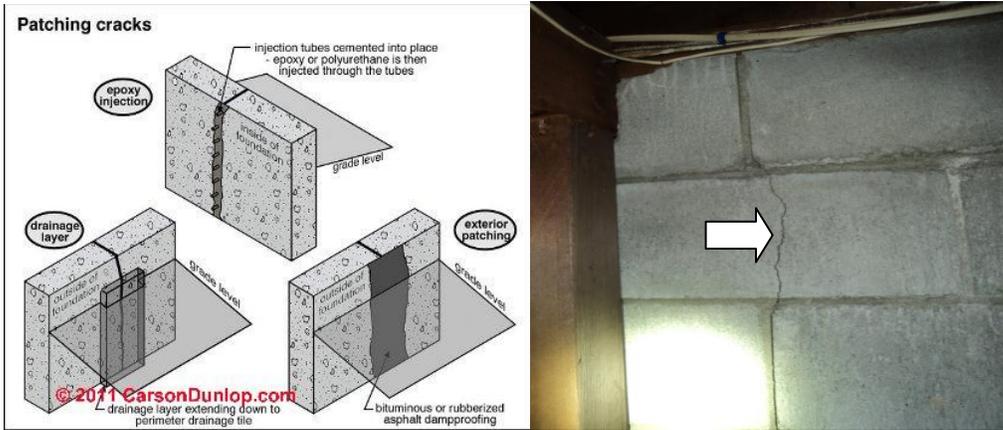
At the time of the inspection the house had some settling cracks. Due to the very nature of cracks water may seep through at certain times. Recommend checking with the current homeowner as to whether the house has had any water problems in the past and if it has, recommend consulting a water proofing company. All cracks should be sealed to prevent leaks or water freezing in cracks and cracks expanding.

Sketch below shows three common methods used to seal cracks in masonry walls in an effort to stop foundation leaks.

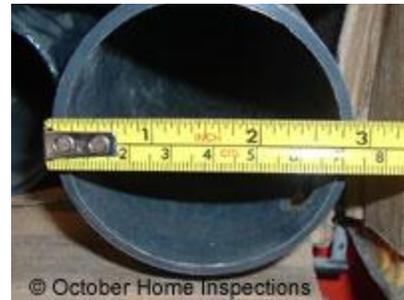
Telescoping adjustable columns are also known as "tele posts," "sectional columns," "double-sectioned columns," "jack posts," or "jacks." They come in two or more hollow steel tube sections that are assembled on site. A smaller diameter tube is fitted into a larger diameter tube and the sections are held in place with steel supporting pins which pass through the pre-drilled holes of both tubes. Telescoping adjustable columns are regularly used in construction to adjust or level a structure before installing a permanent column. Or, they're used as temporary supports during the course of a building repair. But many inspectors in the U.S. encounter these telescopic columns in permanent use.

This is a defect because no telescopic adjustable column has been evaluated by a U.S. evaluation firm and none of their manufacturers cite an engineering report to prove these columns' ability to carry a specific load. Also, according to the IRC, a steel column has to be at least 3 inches in diameter. All telescopic columns are all less than 3 inches in diameter. You must therefore assume that these adjustable columns are not designed for permanent structural use. Think of these telescopic columns the way you would think of a car jack. They only exist to temporarily "jack up" a part of a building and should be replaced with a permanent column when the jacking up is done.
